Report on July 5, 2011 Storm Event at the Ivanpah SEGS Construction Site August 10, 2011 Business Meeting Informational Item

Christopher Dennis, Engineering Office
Siting, Transmission and Environmental Protection Division

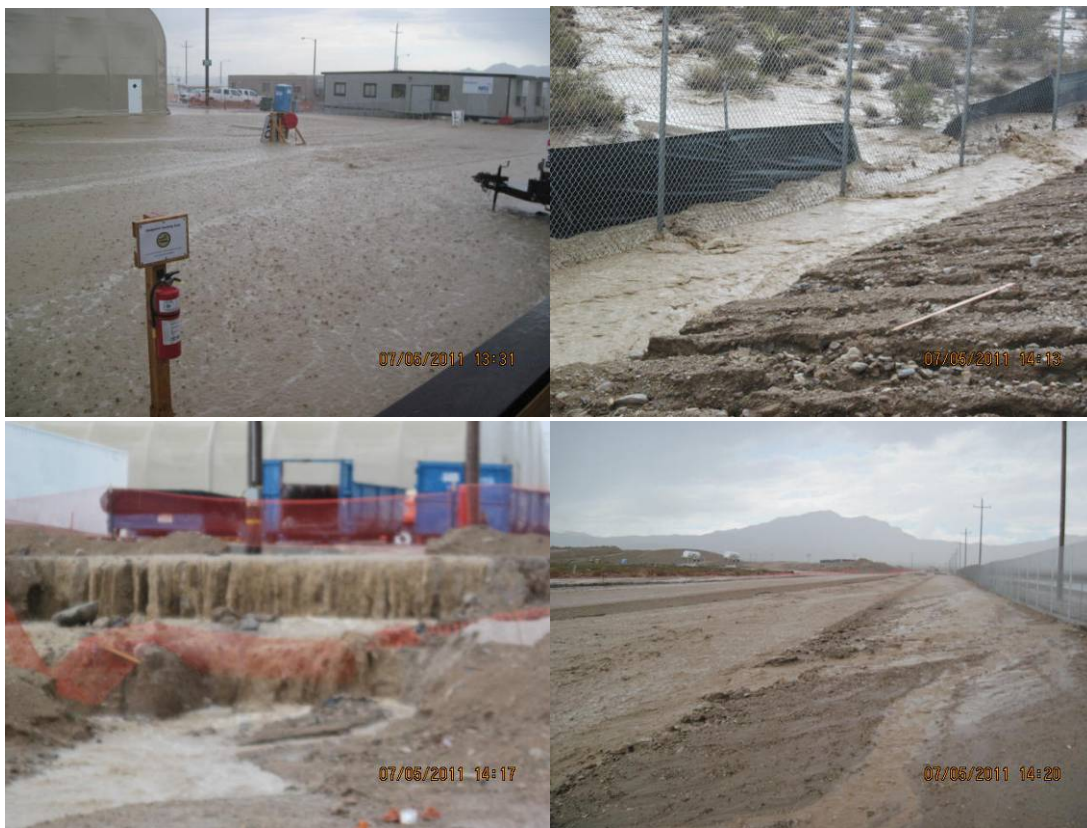
Photos 1 - 4. Storm water flow in the Common Area. The soil in this area is disturbed.

In the disturbed areas, three main areas under construction were impacted. A culvert under construction drained into an open utility trench, also under construction, filling the trench with storm water until the storm water breached the trench walls and flooded down slope. A drainage channel under construction filled with sediment and sediment clogged a down slope culvert that was under construction. A diversion berm, under construction, concentrated storm water flow to a linear silt fence down slope of the well pad/switchyard area (Photos 13 through 17). The silt fence not installed in accordance with California Stormwater Quality Association (CASQA) Best Management Practices (BMPs). The silt fence caused further concentration of the storm water flow until the silt fence failed to withstand the pressure of the sediment and water it was holding and flooded the down slope parking, construction trailers, and fabrication buildings area. The improper use of the silt fencing¹ and its subsequent failure resulted in the erosion and sedimentation shown in Photos 1 - 4.

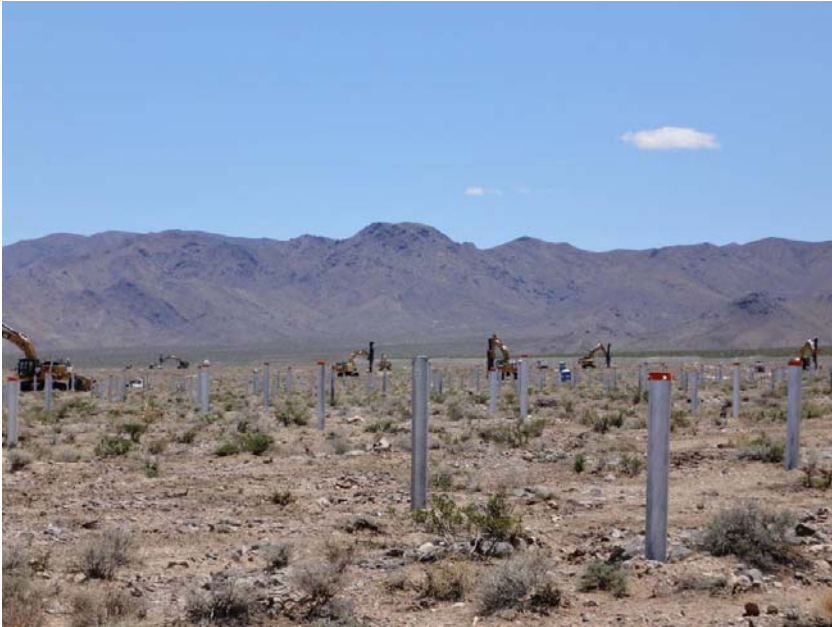
Photo 5. Ivanpah 1 Pylon Field. Vegetation has been mowed and ring roads cut in Ivanpah 1. No significant erosion or sedimentation change. This view is looking up slope.

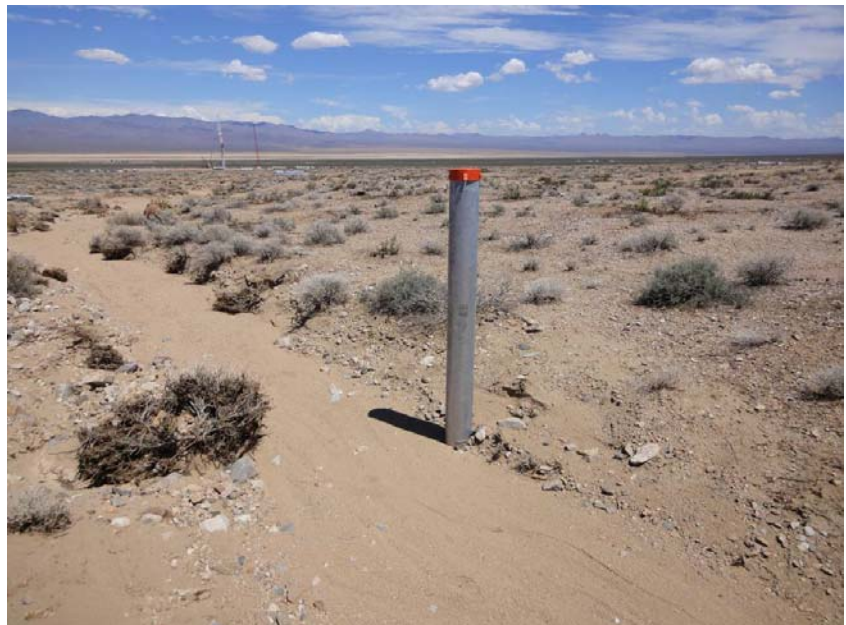
Photo 6. Pylon in Stream Channel. No scour or sedimentation evident around this pylon, while others had some scour. This view is looking down slope in Ivanpah 1.

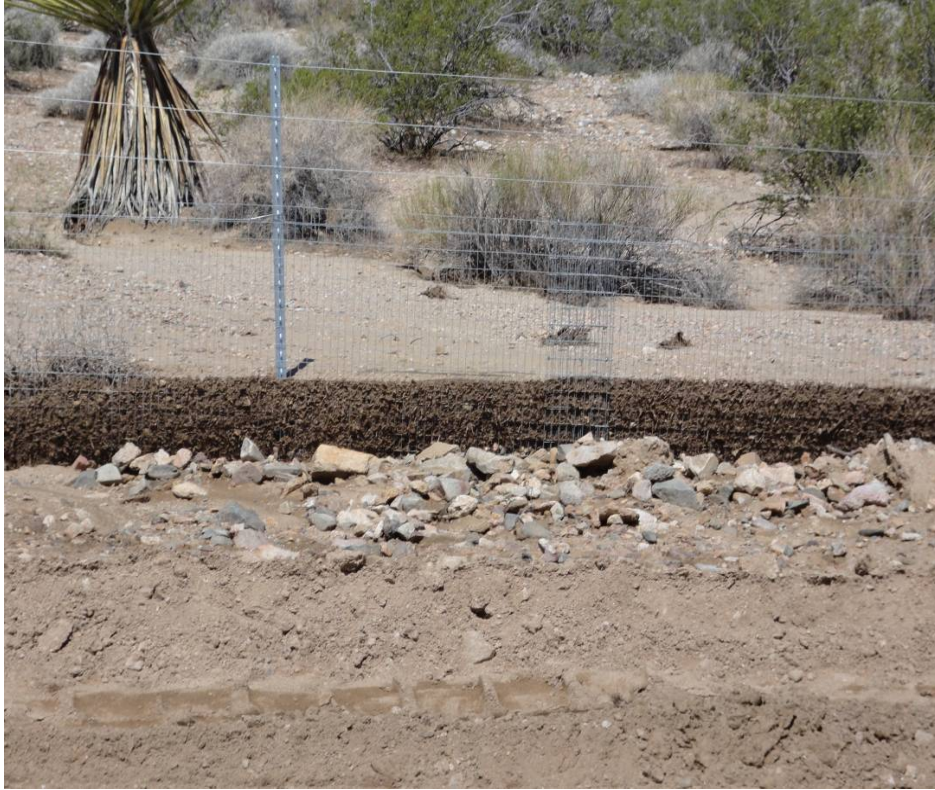
Photo 7. Matted Vegetation. This is an example of the vegetation mat/dam that formed on the tortoise fencing. The fencing is parallel to the ground slope.

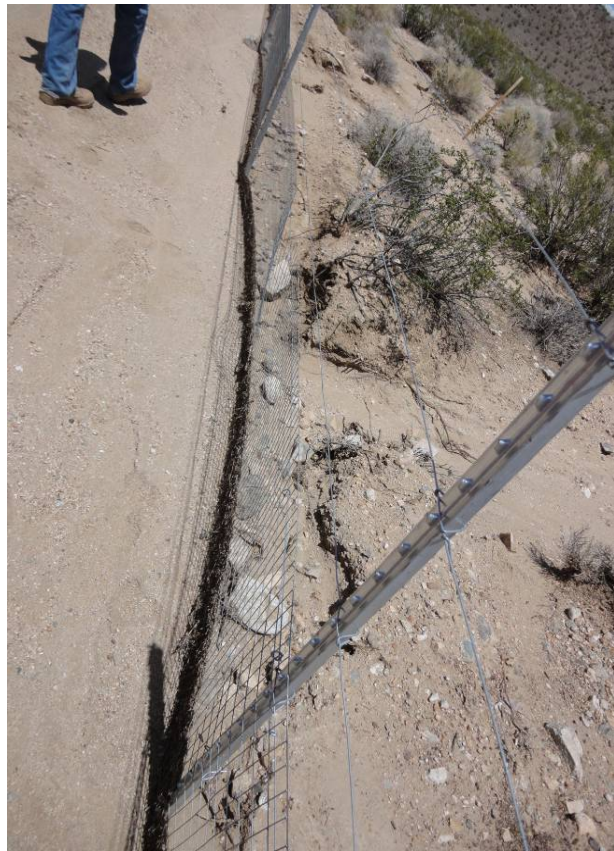
Photo 8. Bowed Tortoise Fence. The vegetation mat/dam trapped the sediment which caused the tortoise fence to bow out. The stream channel slopes down towards the right.

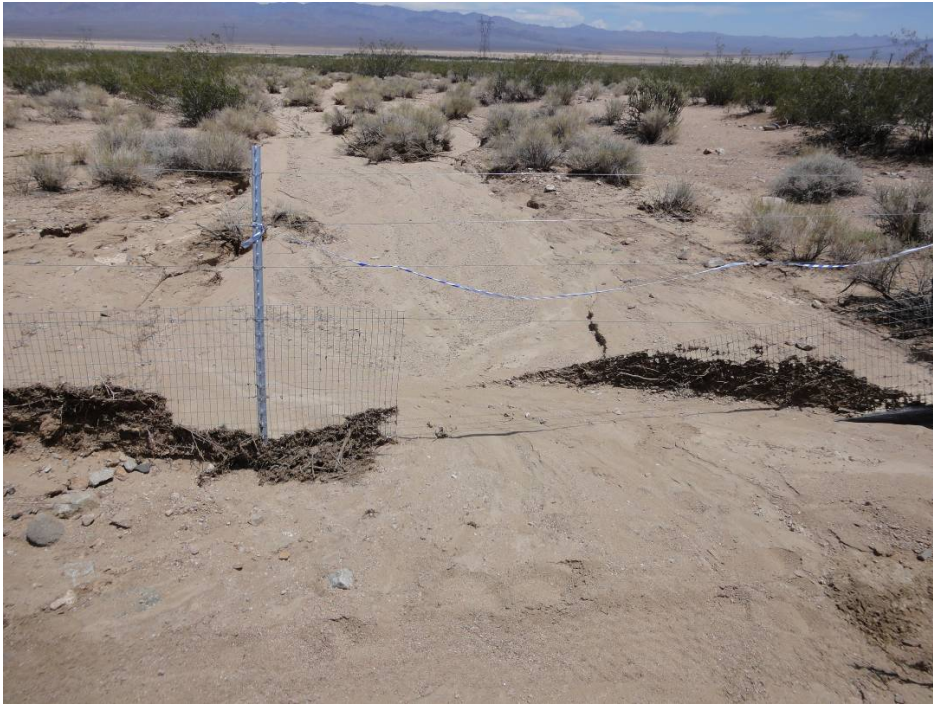
Photo 9. Failed Tortoise Fence. The vegetation mat trapped sediment behind it which caused failure of the tortoise fence. This view is looking down slope.

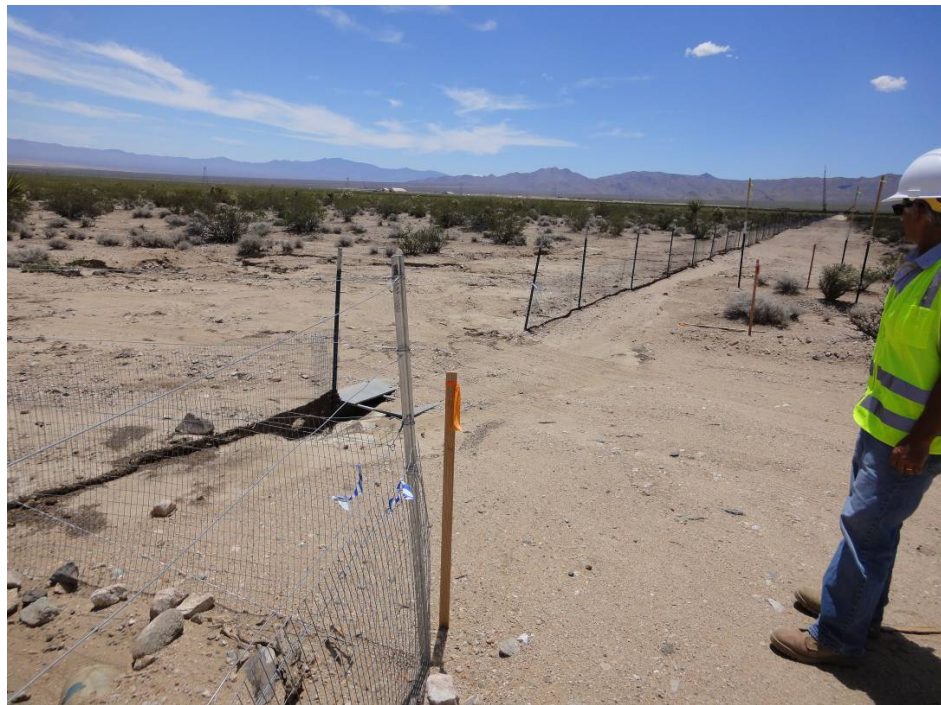
Photo 10. Tortoise Guard Filled with Sediment. Storm water carried sediment to this guard, depositing sediment until it filled the guard. This view is looking up slope.

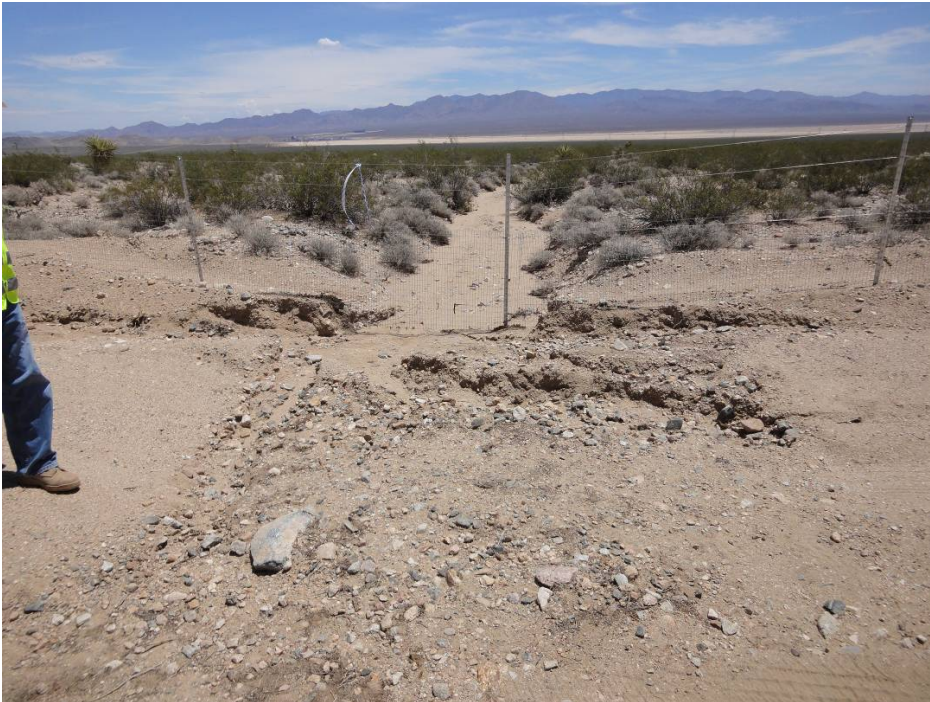
Photo 11. Streambed Eroded Back to its Baseline. This streambed eroded back until it equilibrated with its baseline, causing the bottom of the tortoise fence to be exposed. This view is looking down slope.

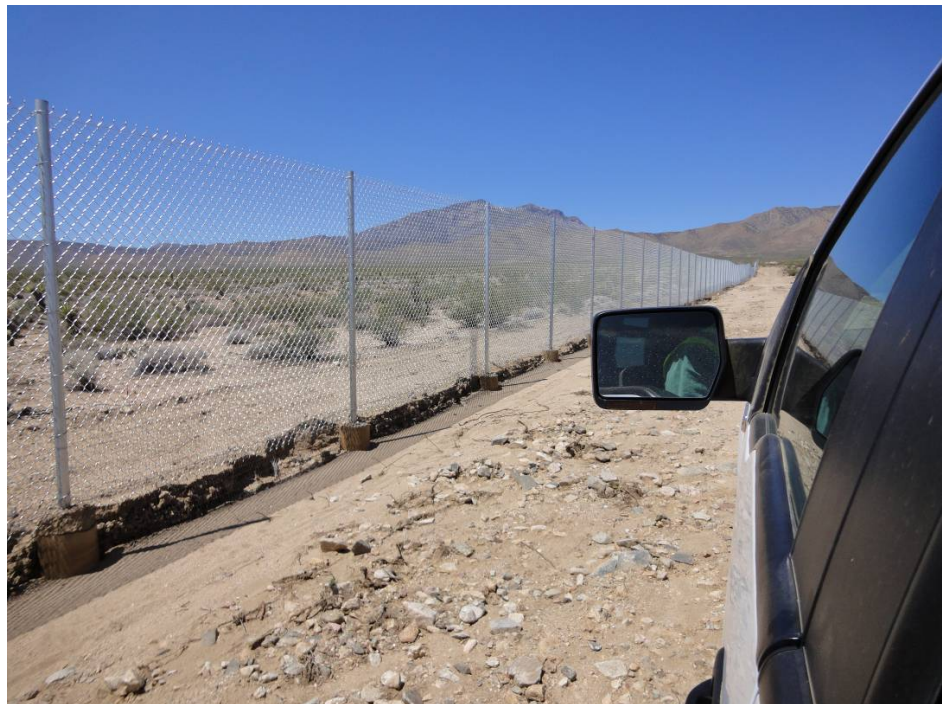
Photo 12. Fence Line Erosion. Erosion along the fence line paralleled the slope direction. Erosion may have been caused by the storm water preferentially eroding the non-compacted soil along the fence rather than the compacted soil of the road. This view is looking up slope.

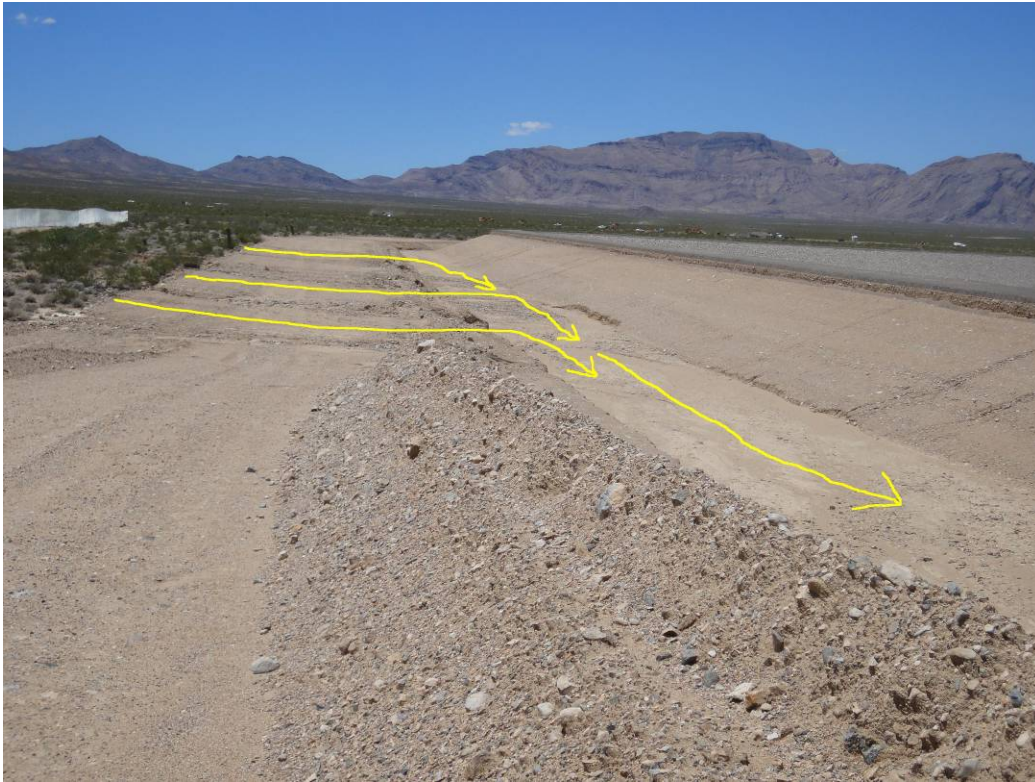
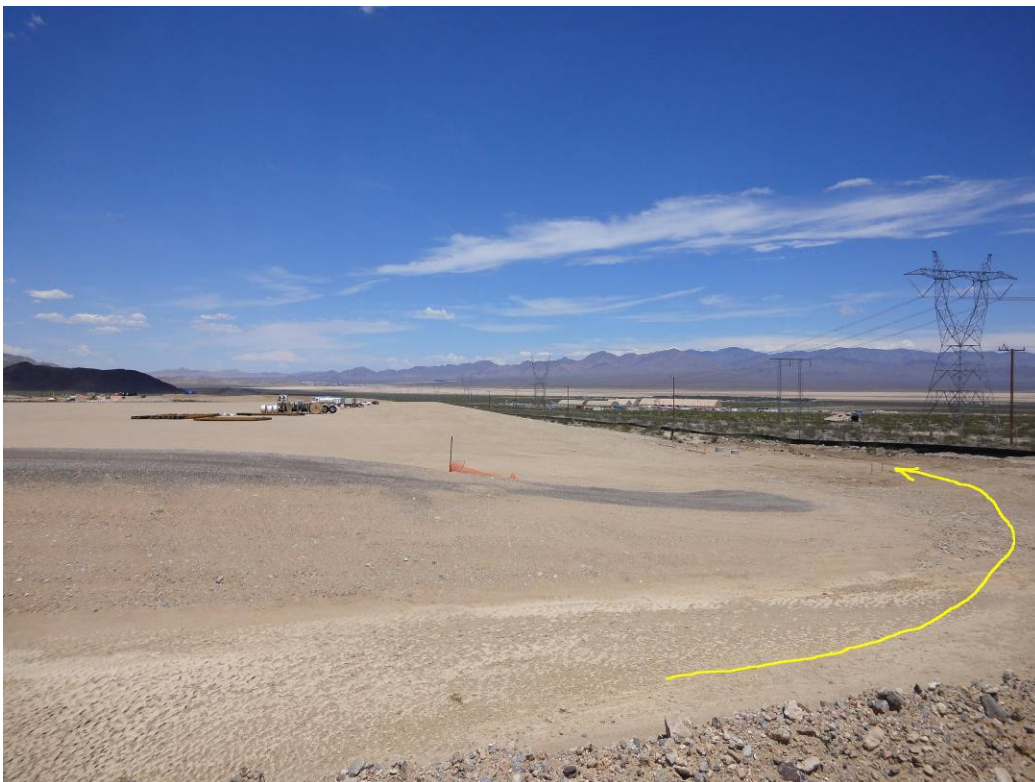
Photos 13 above and 14 below. Concentration of Storm Water by the Diversion Berm. The pictures above and below show the direction of storm water flow along the incomplete protective berm upslope of the Common Area. This berm is still under construction.

- Complete the storm water diversion berm up slope of the Common Area. Completion of the diversion berm hinges on the design and construction of an associated culvert, which needs to be coordinated through the Los Angeles Department of Water and Power and the project owner. Once completed, the berm will divert storm flow to the heliostat field of Ivanpah 1, where the flow will be dissipated and reintroduced as sheet flow to allow the naturally developed drainage system to carry the flow.

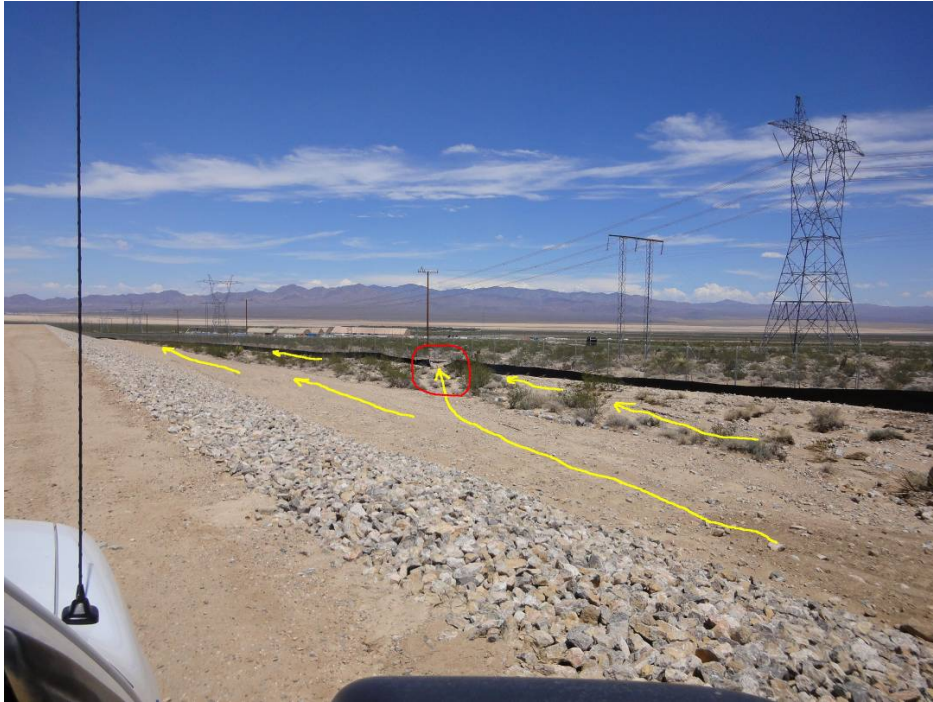
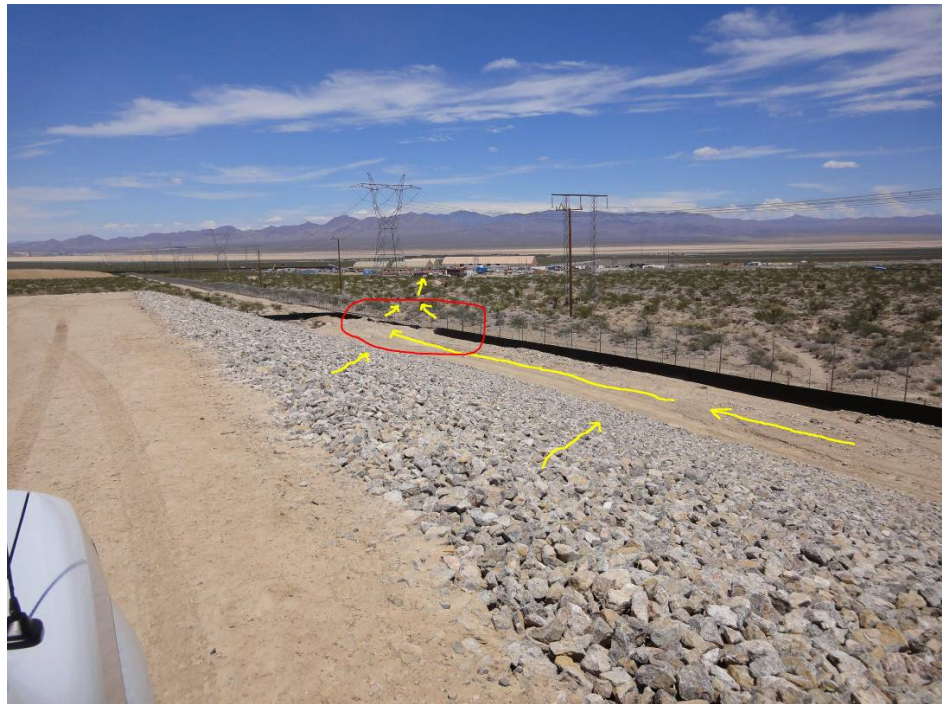
Photos 15 above and 16 below show how the storm water flow was concentrated by the silt fencing. Continuing from the previous pictures, the picture

above and below shows the direction of storm water flow down slope towards parking, construction trailers, and fabrication buildings area. Areas circled in red show where the storm water flow blew out the silt fencing. The silt fencing was not installed in this area in accordance with CASQA BMPs. The silt fencing helped concentrate the storm water flow and accelerate erosion and eventual sedimentation.

- Use silt fencing in accordance with the recommendations of CASQA.
- The silt fence between the well pad/switchyard area and the temporary trailer, parking, and fabrication area should be removed or modified to mitigate erosion across the fabrication pad and excessive sedimentation offsite while maintaining protection of adjacent property along the Southern California Edison easement.

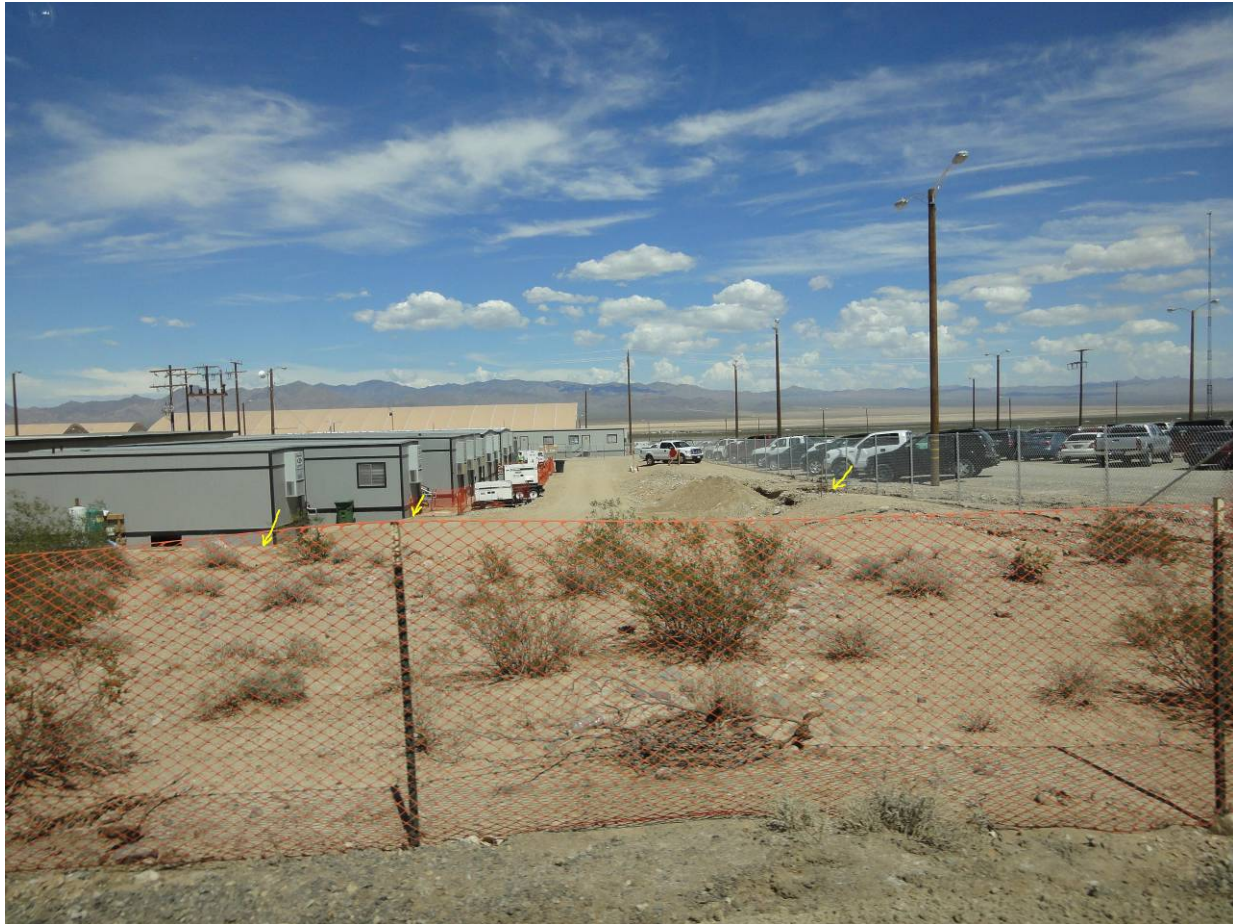
Photo 17. Storm Water and Sediment Flow to the Parking and Trailer Area. This picture shows the amount of sedimentation (arrows to the left) and erosion (arrow to the right) in the trailer area. This erosion and sedimentation resulted from the incomplete construction of the diversion berm and installation of silt fencing that concentrated the storm water and sediment flow to this area.
